**RIO VISTA NATURAL RESOURCE PARK**

# **MASTER PLAN REPORT**

**CITY OF  
TUCSON**  
PARKS & RECREATION

Prepared By:  
**SMITHGROUP**

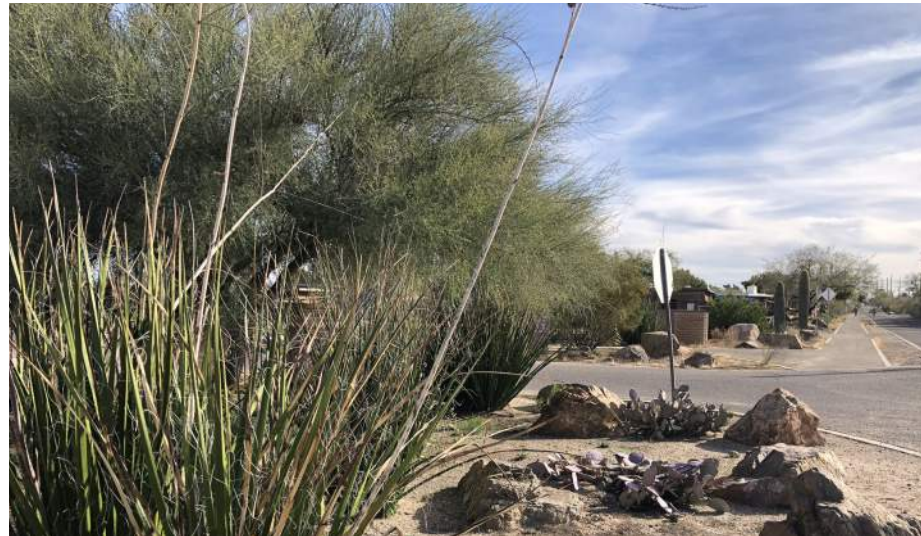
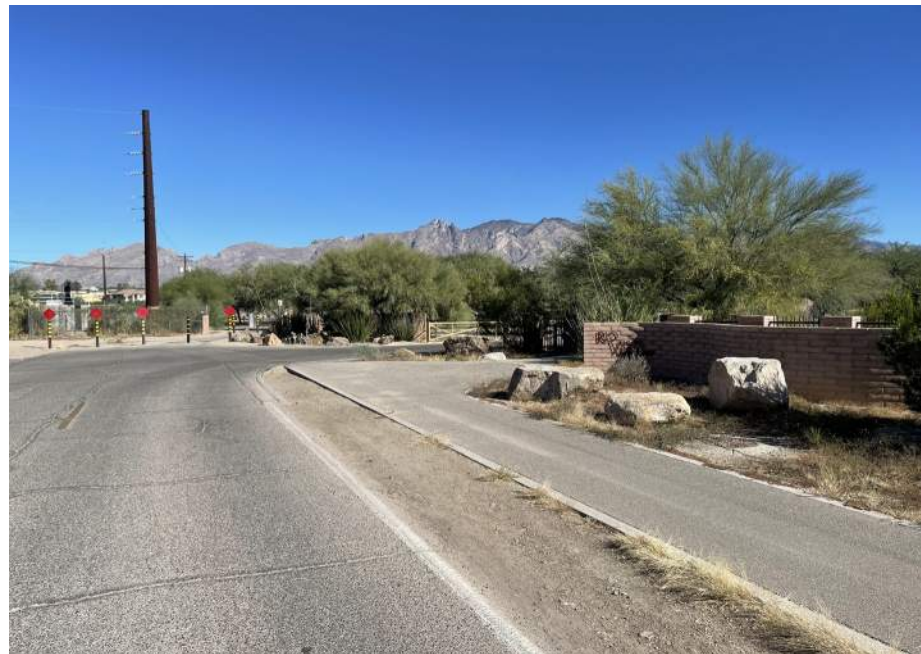
The west entry is also the primary visitor entrance into the Rio Vista Natural Resource Park. The entry is located along Tucson Blvd. adjacent to Hitching Post Ranch at Gentleman's Acres. The main access point to the Loop is from the park entrance.

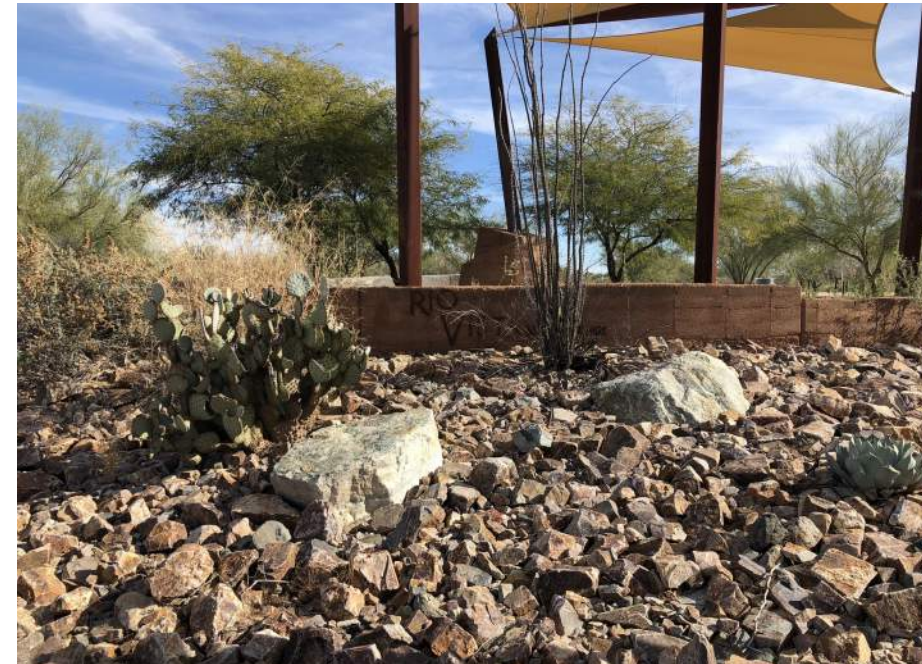
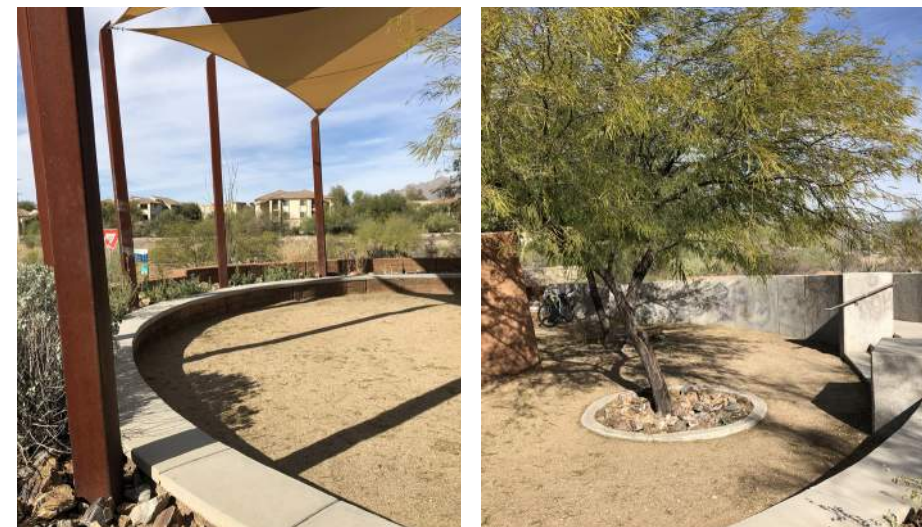
The plaza is at the northwest entrance to the park from the Loop. Along the perimeter of the plaza there is region appropriate desert landscape that is well established and maintained. The signage into the park does not stand out and needs to be highlighted.

The shaded gathering area is accessible by stairs and an ADA ramp.

- Repair and repaint wall as needed.
- Adjust planting for better visibility of entry signage.

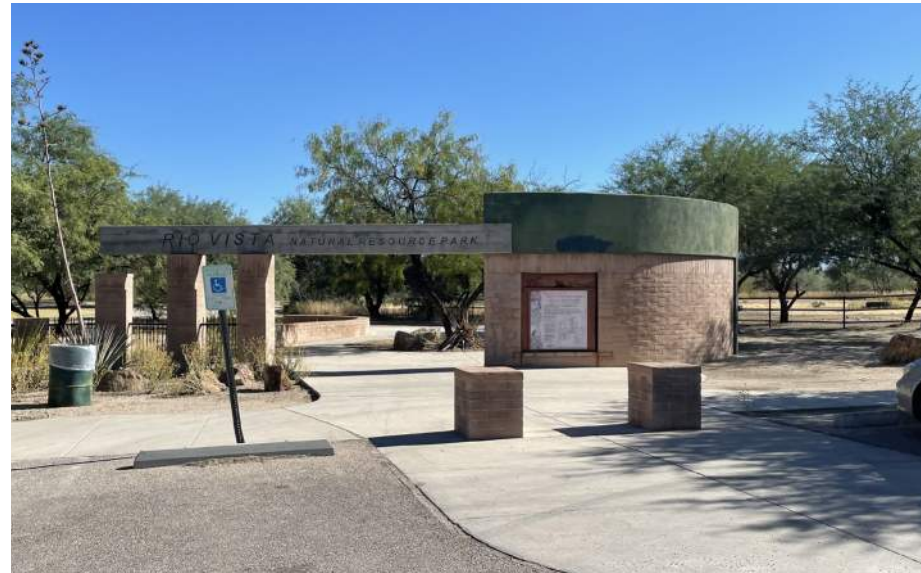
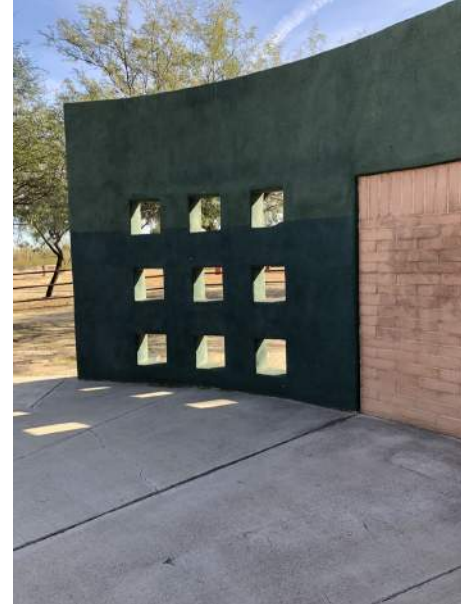
The entry plaza is the main pedestrian entrance into the developed portions of the park. It is located on the west side of the property and is accessible from the parking lot entrance on Tucson Blvd. The plaza serves as a gateway to the park areas and includes seatwalls for gathering and is adjacent to the Interpretive Garden. The paint finish on the entry structure is faded and in need of a refresh. The park structure includes park signage that is faded.

- Repair stucco finishes and paint
- Replace/update signage and interpretive graphics
- Update adjacent landscape for aesthetics, wayfinding, and celebrating the entry

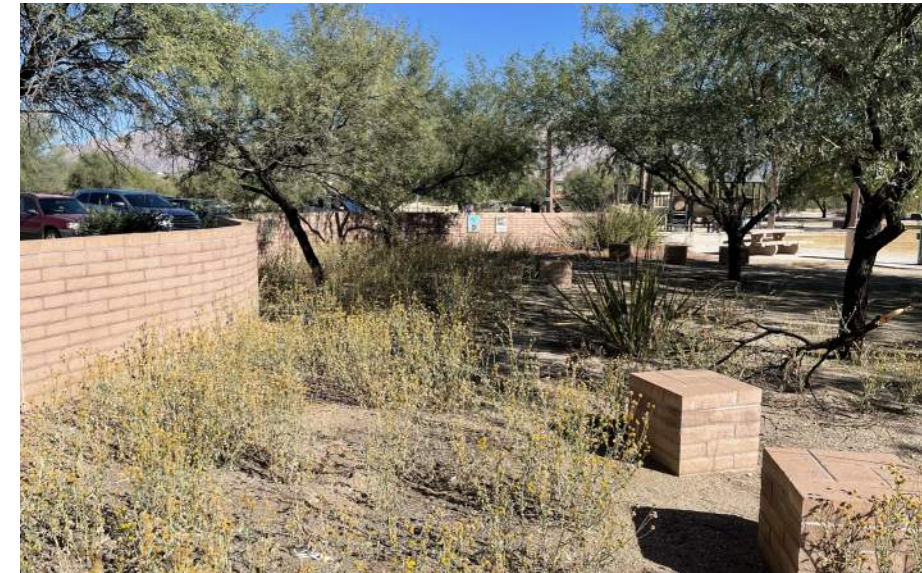
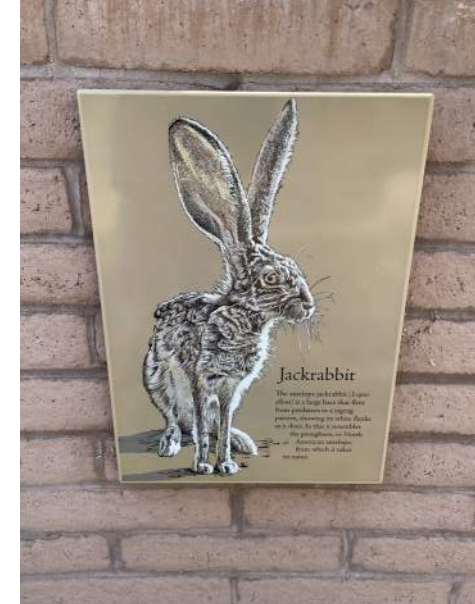
The Interpretive Garden is located north of the plaza and in close proximity to the play area. The garden includes several educational signs attached to the low wall separating the area from the parking lot. The interpretive signs highlight types of wildlife, but are too small in scale and not accessible by a clear path. A small ramada is located in the Interpretive Garden and is a fun interactive piece for children. Landscape in the garden is stressed and does not offer much species variety.

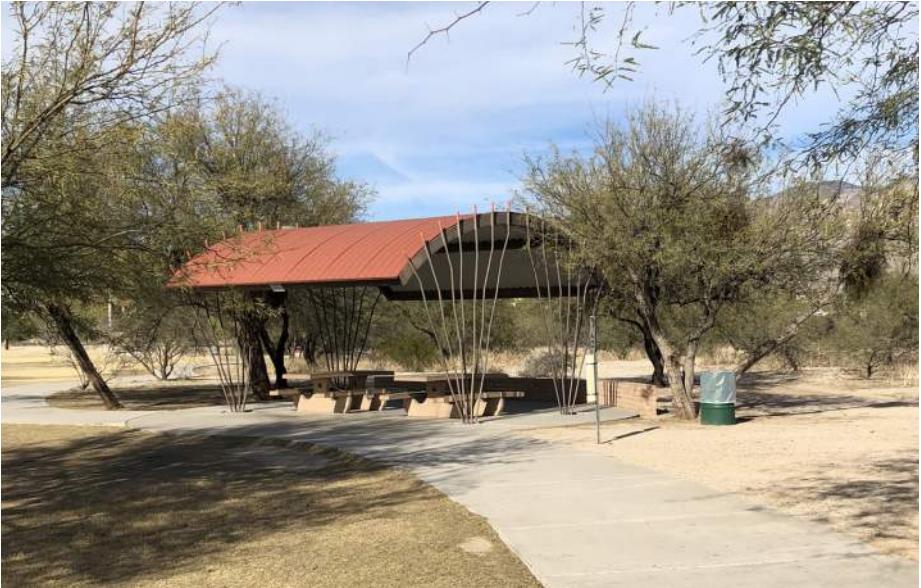
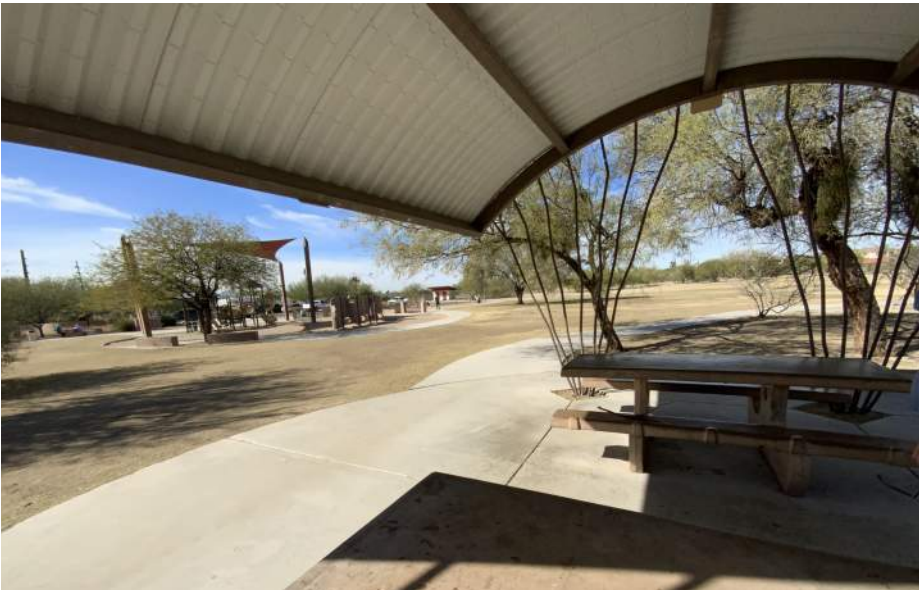
Each ramada includes picnic tables and a trash receptacle. They are easily accessible from the concrete sidewalk that circles the playground and open grass areas. The ramadas appear to be in a good condition.

- Refurbish and repaint as needed

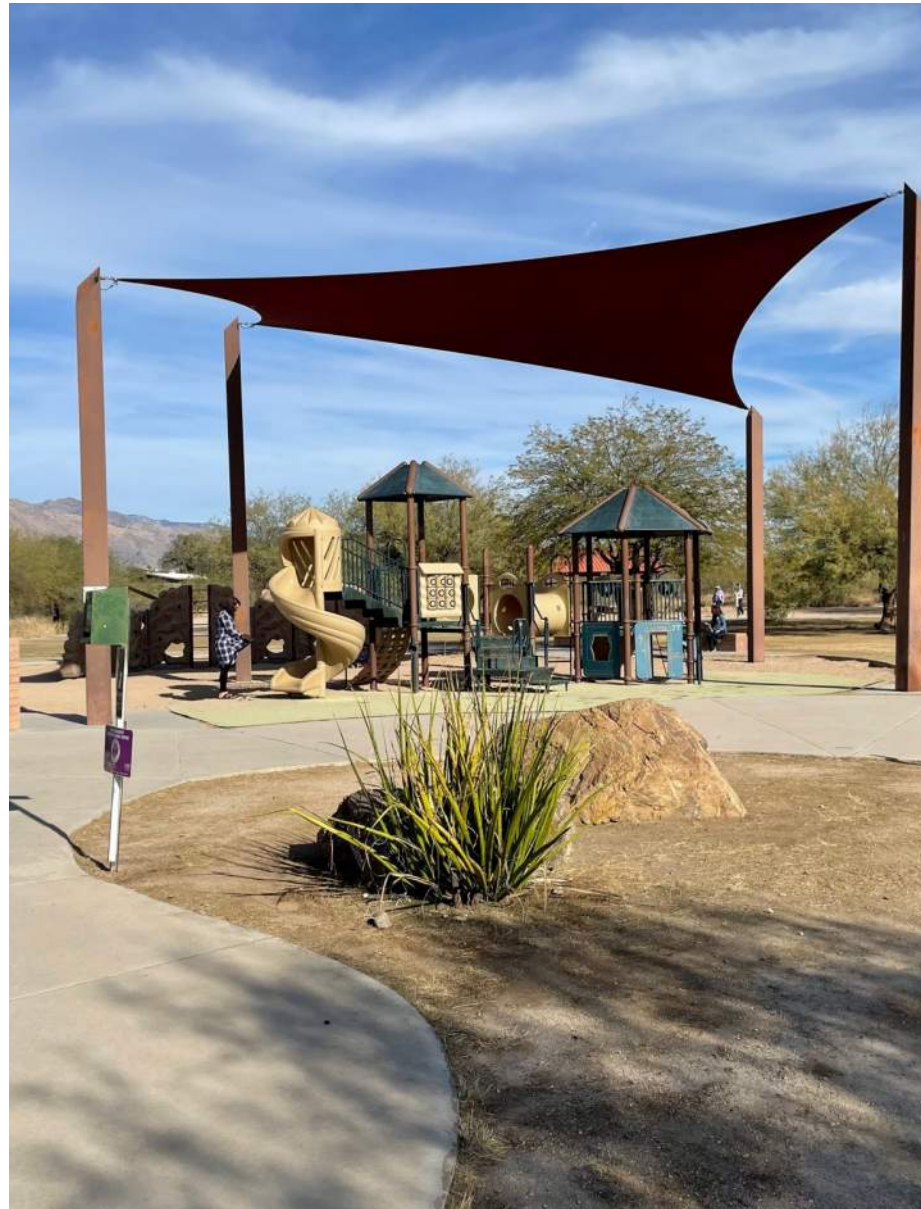
The play area is accessible from the parking lot located off of Tucson Blvd. It is adjacent to the open grass area and is shaded by a large tensile shade structure. The area includes a play structure with elements for toddlers and older children. Minimal landscape surrounds the play area other than grass. Seatwalls are located around the edges of the playground area.

- Increase variety of play equipment options for different age groups
- Refresh landscaping with variety of plant species
- Evaluate condition of playground surface and replace as needed

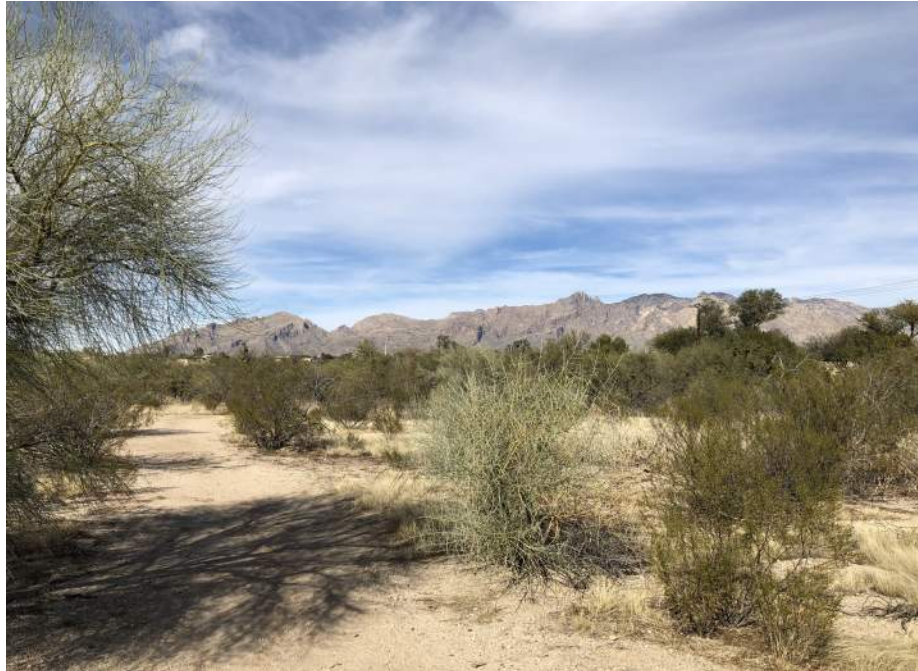
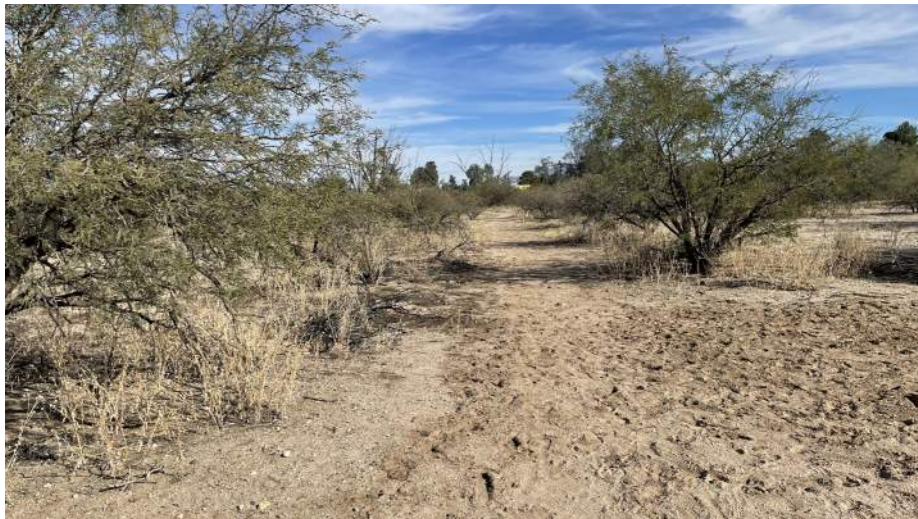
Apart from the open grass area and the aesthetic plantings at pedestrian entries, the overall feel of the landscape within the park is desert region appropriate and respects a native plant palette. Within the trail network the landscape is naturalistic with some dense, riparian landscape along Shannon Wash and at the southeast corner of the site. There is a patch of Eucalyptus trees at the southeast corner of the site along Cactus Blvd. The Eucalyptus trees are at different stages of life but are home to wildlife. There have been some noted invasive Salt Cedars in the landscape areas.

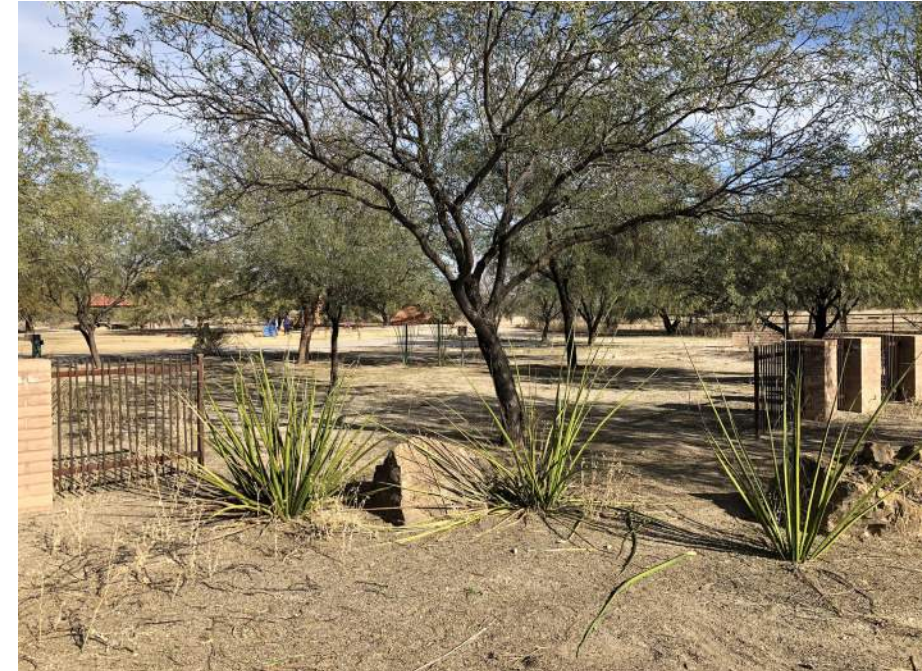
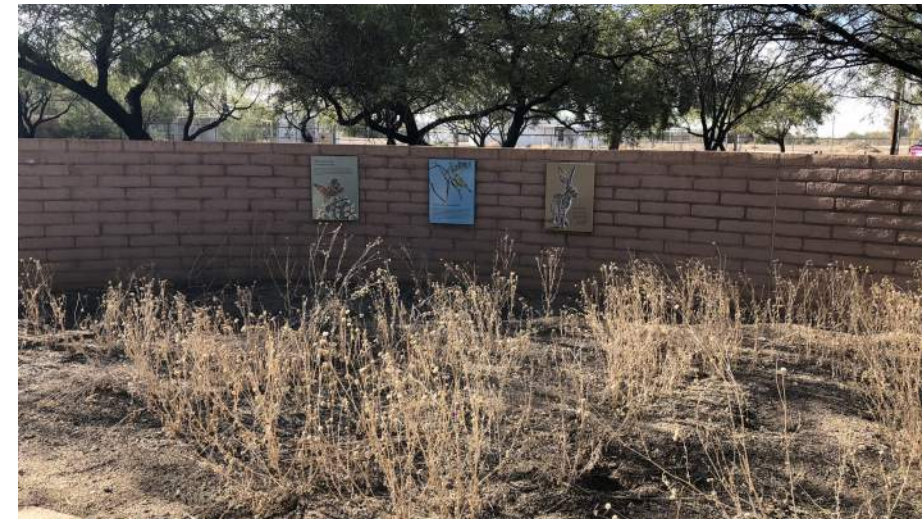
The Interpretive Garden landscape does not include a lot of landscape variety such as seasonal color, size, and texture. Aesthetic planting at entries could use an update. Paths to the educational interpretive signage are overgrown with landscape and difficult to determine.

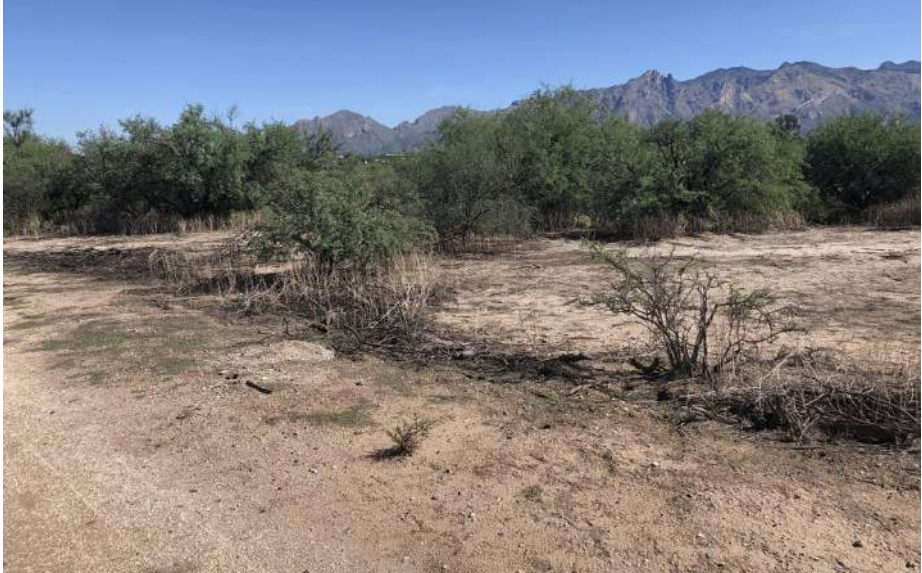
**SHANNON WASH**  
 Shannon Wash is in the center of Rio Vista Natural Resource Park within the trail network. The landscape surrounding the wash is native riparian vegetation. A portion of the wash closest to the equestrian area has been disturbed and is in need of revegetation.

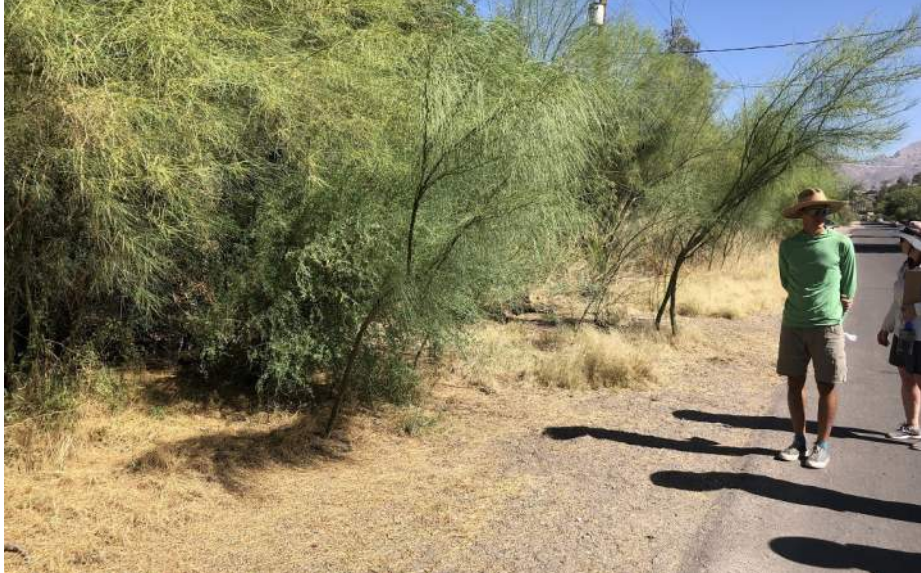
**STORMWATER MANAGEMENT**  
 Existing site disturbances interfere with stormwater drainage throughout the site and to Shannon Wash.

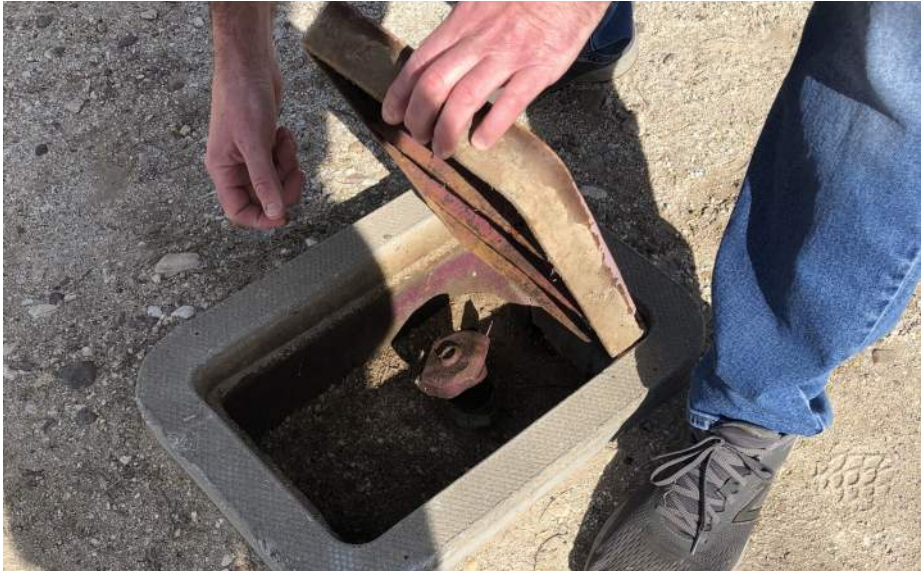
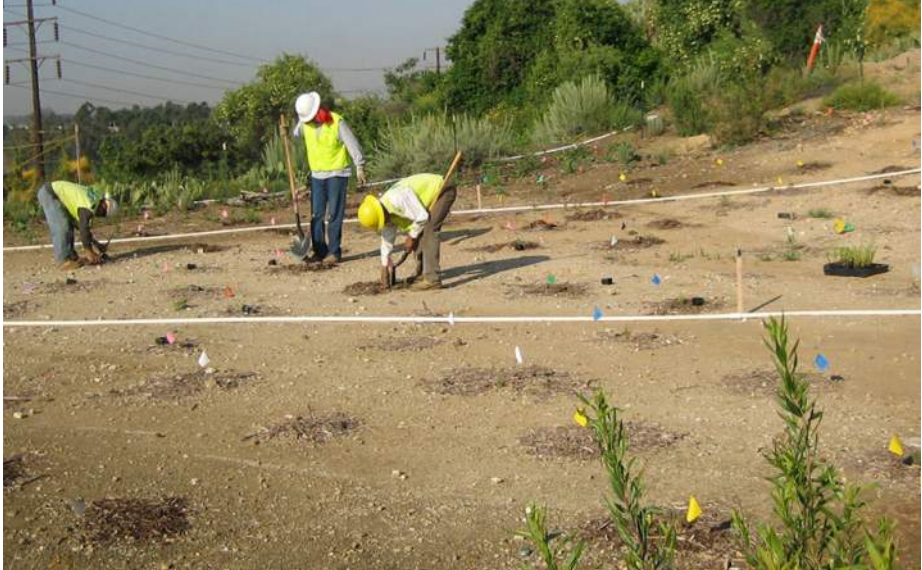
There is an existing irrigation system at the park which needs to be assessed to see if it is functioning properly based on the condition of the plant material throughout the site.

- Establish routine maintenance and repair of irrigation system
- Extend irrigation system through out trail network where revegetation efforts occur

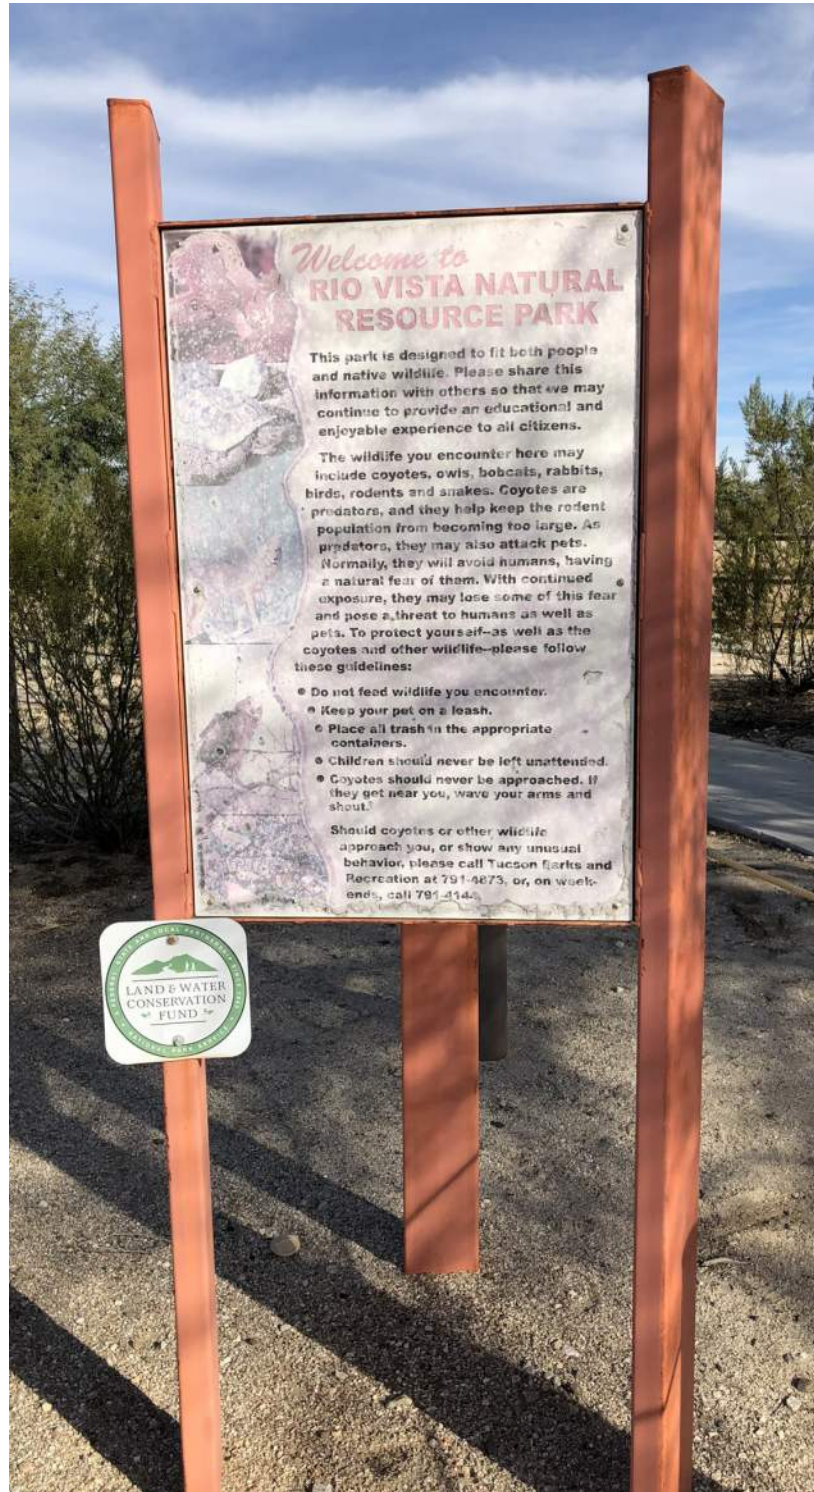
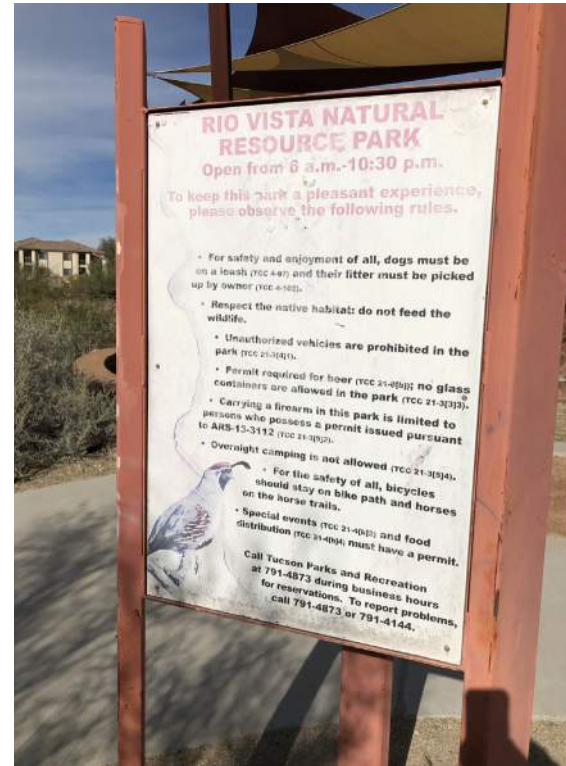
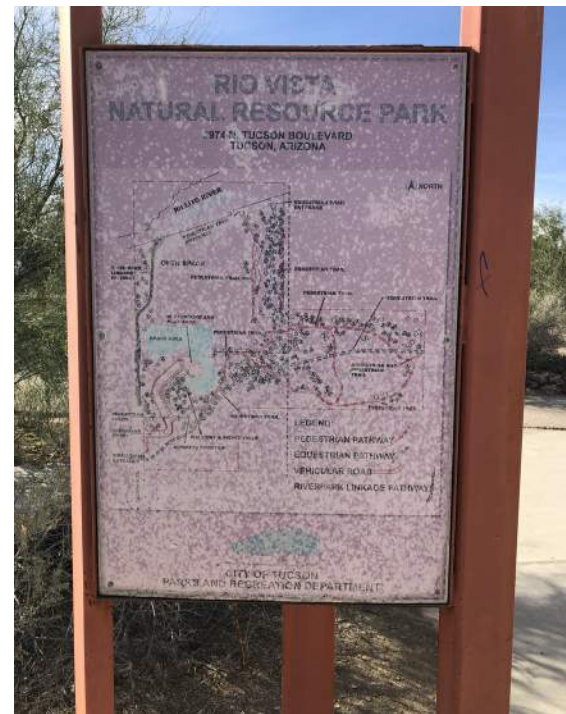
Throughout the site there are (5) park map stands.

The conditions of the maps and information on all panels are faded and difficult to read clearly.

- Replace signage with updated park map
- Include park hours and rules
- Develop new signs to be consistent in design throughout park

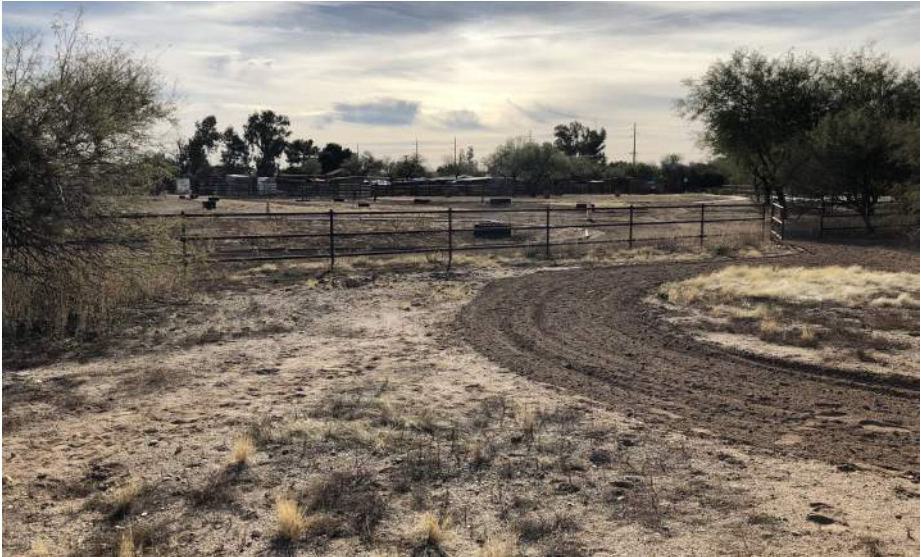
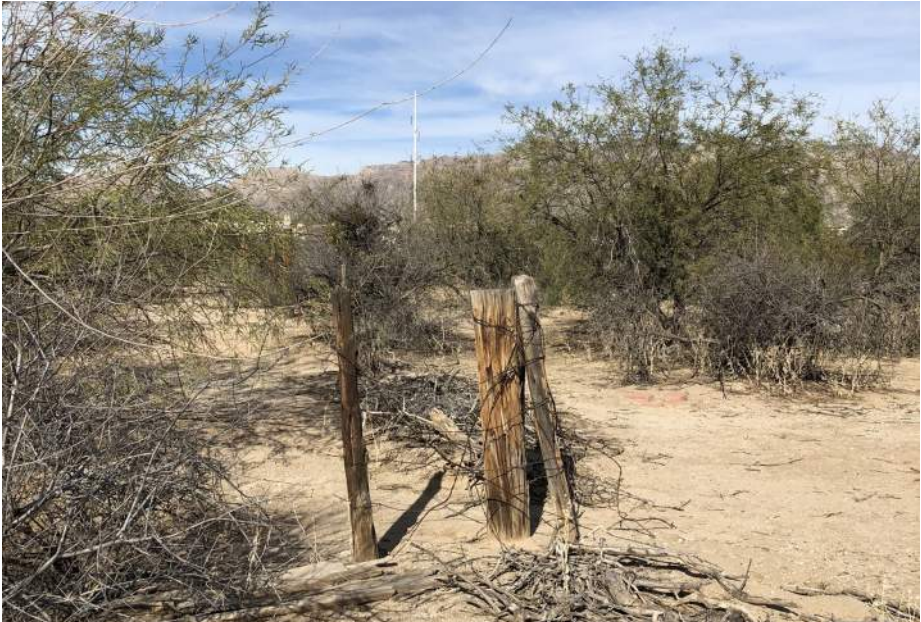
There are currently sections of fence that border the east, south, and west properties; however, there is no fence on the northeast side of the park where it is adjacent to the residential properties. The existing fence is inconsistent in design and condition.

- Add wire fence to missing areas where park borders residential property
- Upgrade equestrian area entry
- Fencing to be consistent in character and design

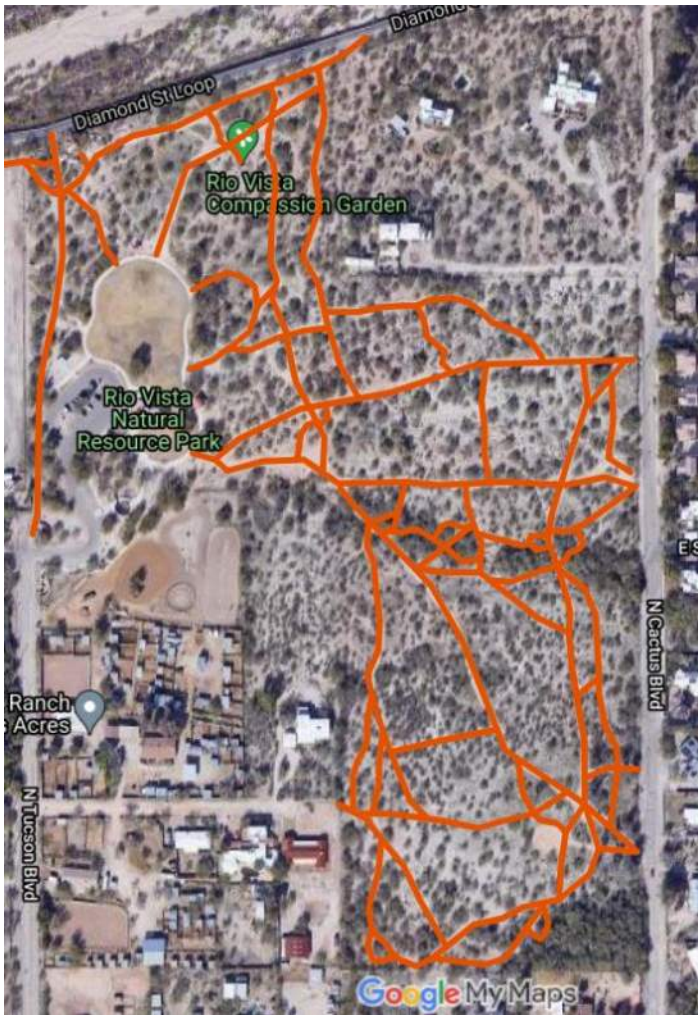
Figure 1. Map of existing trails completed by the Rio Vista Conservation Project in 2019.

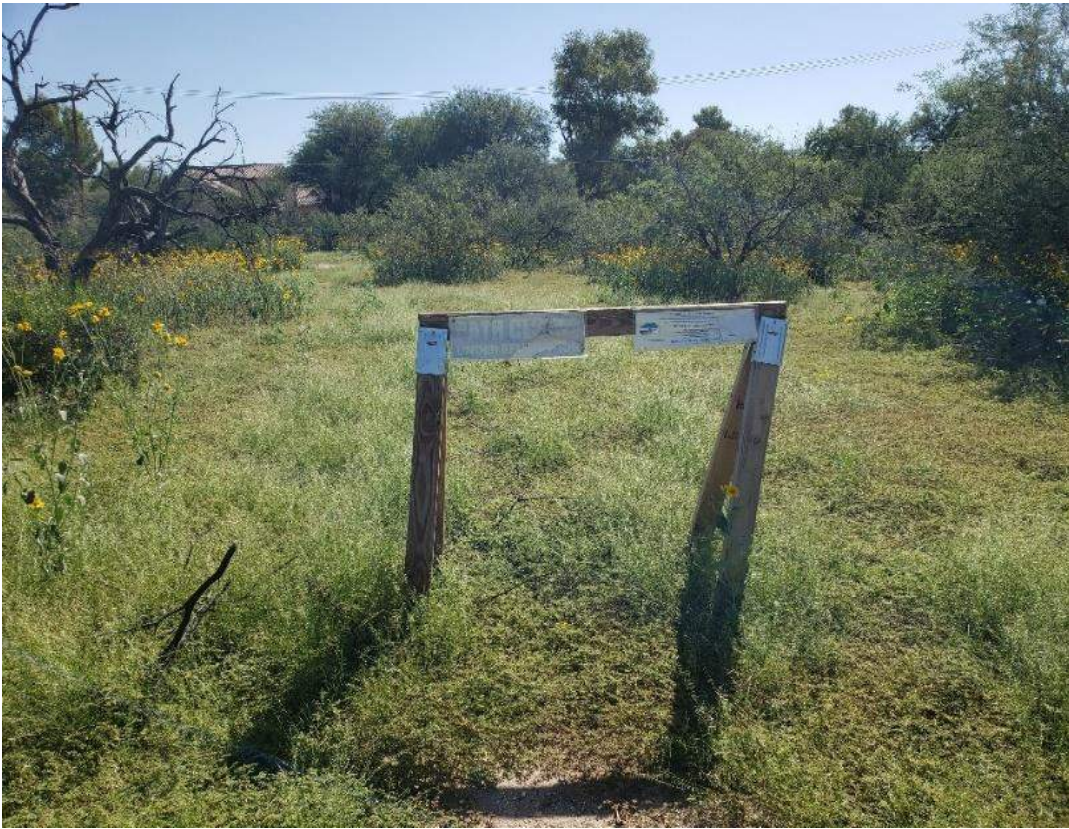
**Photo 1. Trail closure signage on sawhorse. This sawhorse is in need of repair and the signage is faded and illegible.**

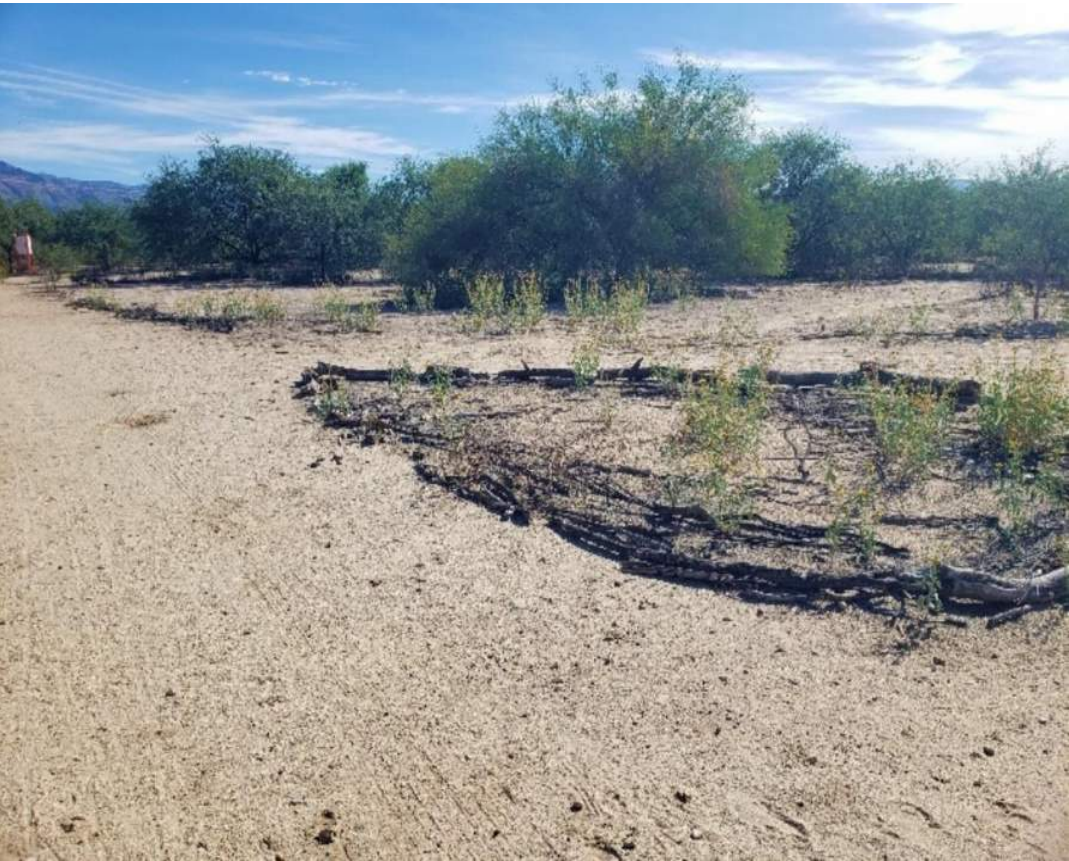
**Photo 2. Example of use of wood brush material to define trails and arrest widening.**
